STM32F051x4/x6/x8 device limitations**Silicon identification**

This document applies to the part numbers of STM32F051x4/x6/x8 devices listed in [Table 1](#) and their silicon revisions shown in [Table 2](#).

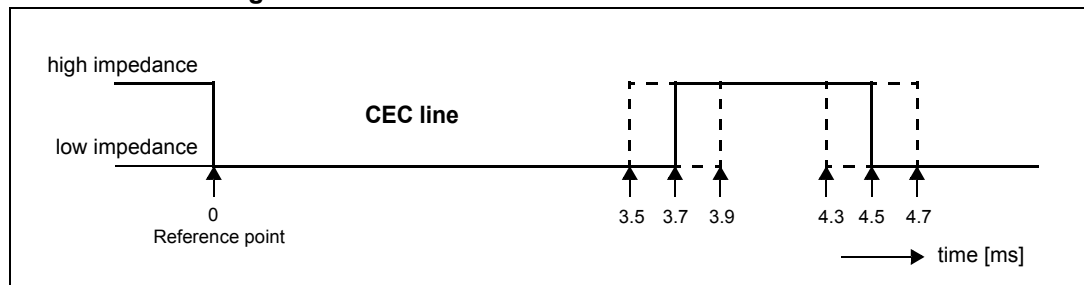
Figure 1. HDMI-CEC start bit format with tolerances

This failure is unlikely to happen as the CEC start bit corruption by another device can only occur if that device does not respect the CEC communication protocol.

The start bit timing standard tolerances are shown in *Figure 1*. The start bit is initiated by the device by driving the CEC line low (reference point). After 3.7 ms, the device releases the CEC line and starts checking its level. The following conditions must be met for the start bit to be valid:

If one of these conditions is not met, the transmission is aborted and never automatically retried. No error flag is set and the TXSOM (Tx Start Of Message) bit is not cleared.

A way to work this limitation around is for the system-level CEC application software to start a time-out counter when setting TXSOM bit and stop it upon TXBR or TXEND event. In case of time-out, the HDMI-CEC functional block is disabled then enabled, by setting the CECEN bit in CEC_CR register to 0 then to 1. This clears the TXSOM bit.
